DAMAGE TO ROADS CAUSED BY OCT. 8, 2005 NORTH PAKISTAN EARTHQUAKE

Obaid Hassan QURESHI ¹ and Junichi KOSEKI ²

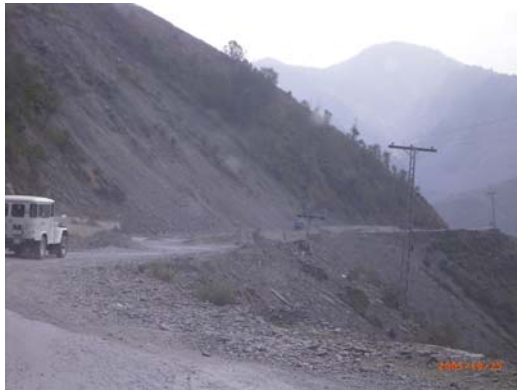
Fig. 4: Road No.1, Site No. 1

Fig. 4 shows the slope failure at Site No. 1 (marked in Fig. 2) located at about 10 km from Muzaffarabad. The failure was surficial nature and the road was cleared quickly after the incident.

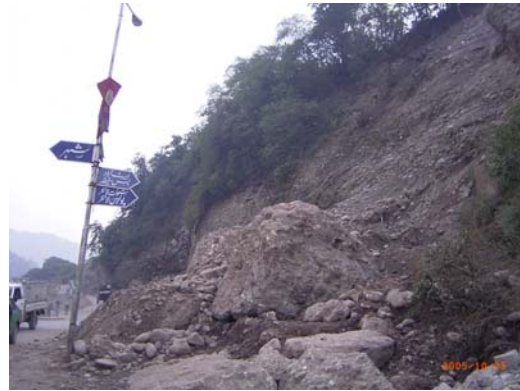
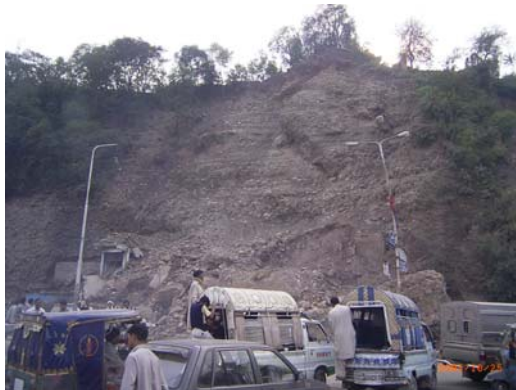
Fig. 5(a): Road No.1, Site No. 2

Figs. 5(a) and 5(b) show the failure of a steep cut slope in the city of Muzaffarabad. This slope has been posing threat for many years. Some shops were constructed right against the slope and were completely damaged by the fall of huge conglomerated alluvial deposit. Similar slope failure is most likely for the slope on local road near Tonga Adda in Muzaffarabad as shown in Fig. 6.

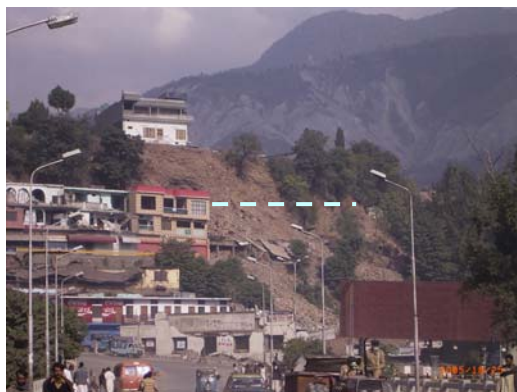
Fig. 7: Local road, Site No. 3

Fig. 7 shows the disappearance of a local road leading to Dhakki Adda in Muzaffarabad. Some buildings on its valley side have also been collapsed.

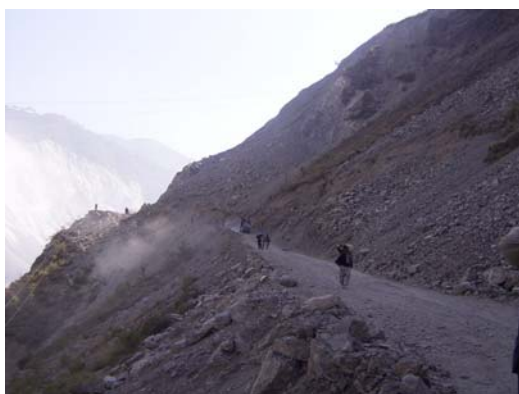
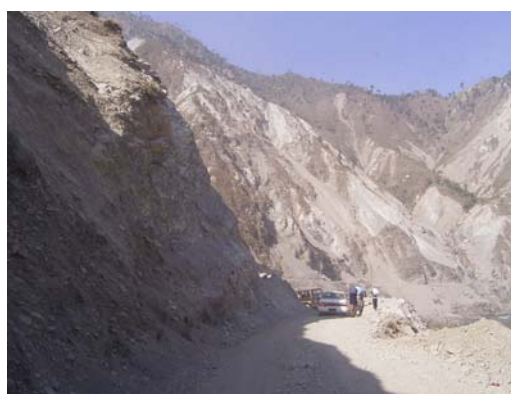
Fig. 8: Road No.2, Site No. 4

Figs. 8 and 9 show that the roadway (Road No. 2) practically disappeared after the earthquake and had to be cleared and realigned. The shown road was paved prior to the earthquake and is now has merely a gravel top layer. Most of the length of this road was closed for traffic at the time of visit.

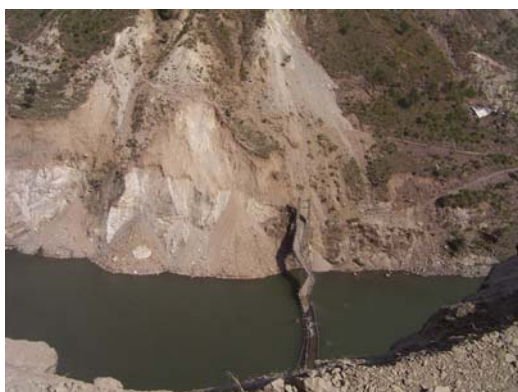
Fig. 10: Road No.2, Site No. 5

A suspension bridge on a local road leading to Dhani Mae, slightly off the Road No. 2, to the north of Muzaffarabad was completely collapsed as landslides toppled the suspension towers as shown in Fig. 10.

A suspension bridge on a local road leading to Dhani Mae, slightly off the Road No. 2, to the north of Muzaffarabad was completely collapsed as landslides toppled the suspension towers as shown previously in Fig. 10.

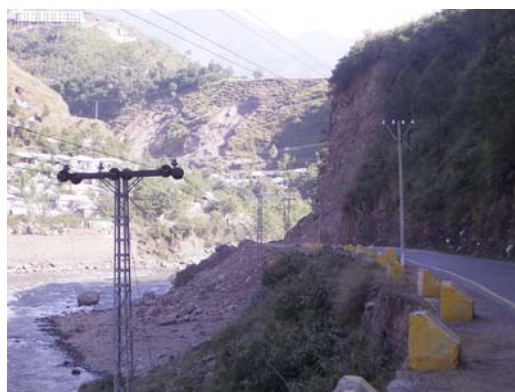
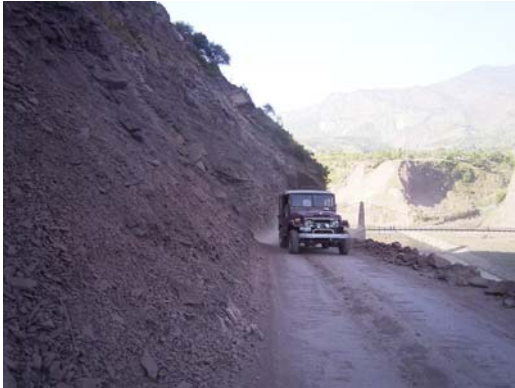
Fig. 11: Road No.3, Site No. 7

Figs. 11 and 12 show the failure of steep natural and cut slope on Road No. 3, in the west of

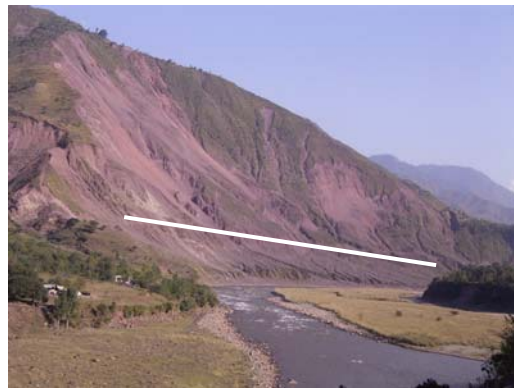
Fig. 13: Local road, Site No. 9

Muzaffarabad, whereas Fig. 13 shows the complete collapse of a local road, located opposite to Road No. 3, due to slope instability.

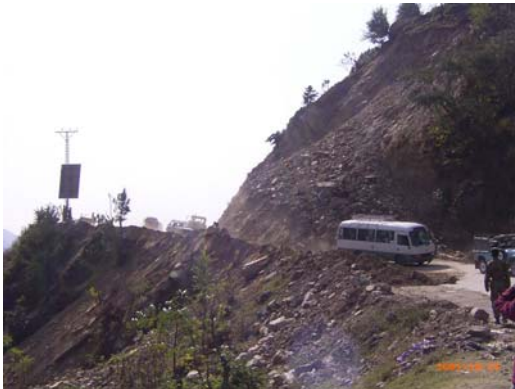
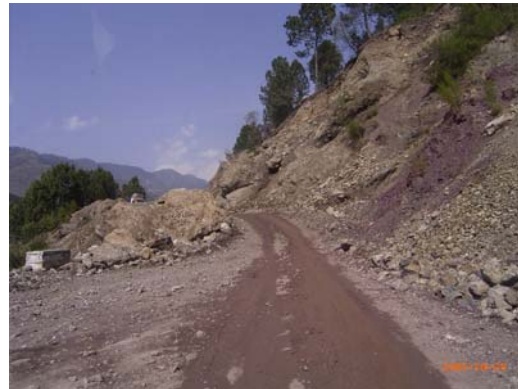
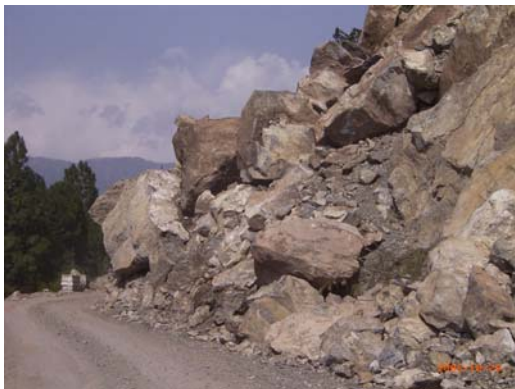
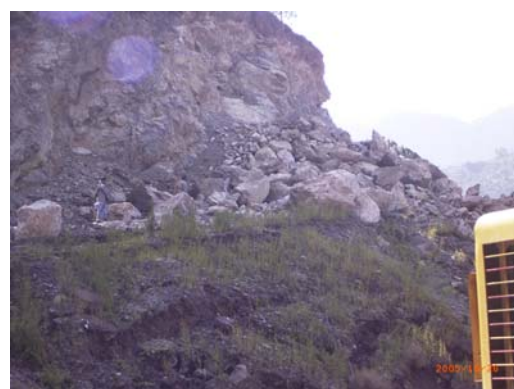
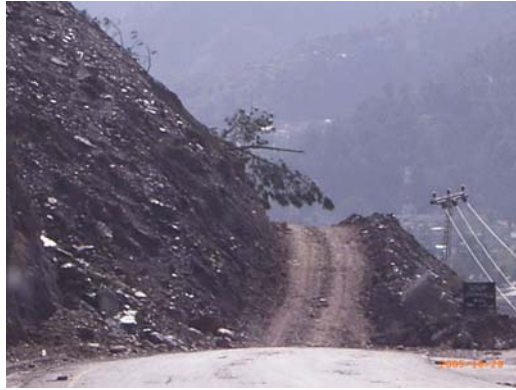
Figs. 14 through 18 show the slope failures on Road No. 5 and 6 around Balakot. These roads were upgraded in the recent years and were performing well until the catastrophe. It is to be mentioned that the wet surface of the road visible in Fig. 15 is artificial sprinkling at the roadway done for the convenience of passengers in order to avoid dust.

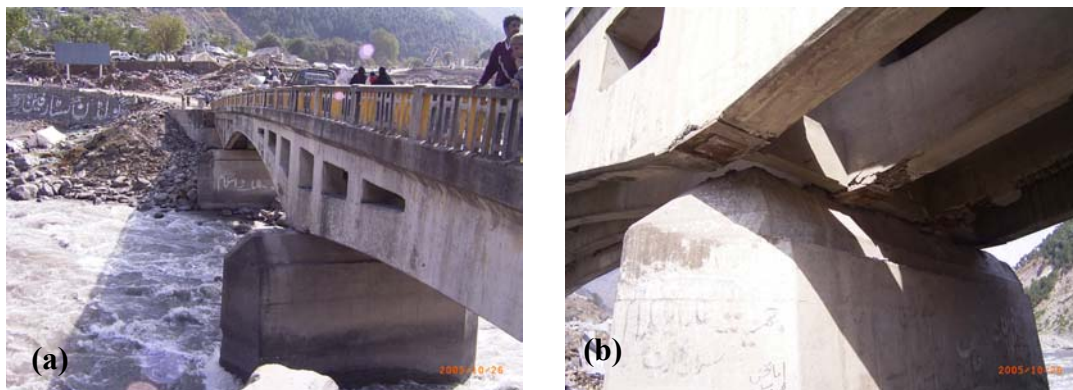
Fig. 19 shows the Balakot Bridge on the Kunhar River, which was knocked off its bearing supports. Lack of lateral restraints allowed displacement of the bridge that resulted in one outer girder hanging freely and other girders left with minimal bearing over their supports.

Fig. 19: Displacement of deck of Balakot Bridge towards south and east.

Vertical motion may have played a significant role in reducing the vertical force on the bearings, leading to the large observed lateral displacement.

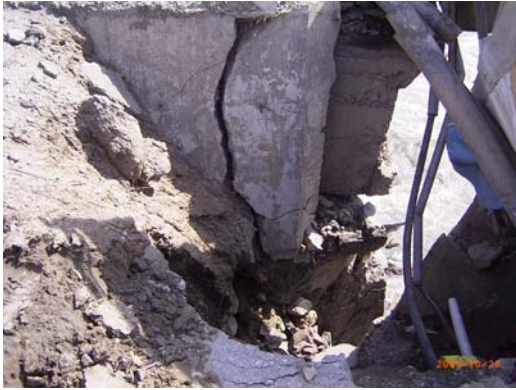
Fig. 20: Abutment failure of Balakot Bridge

Only a few cases of abutment and culvert failure were observed. Figs. 20 through 23 present those cases.

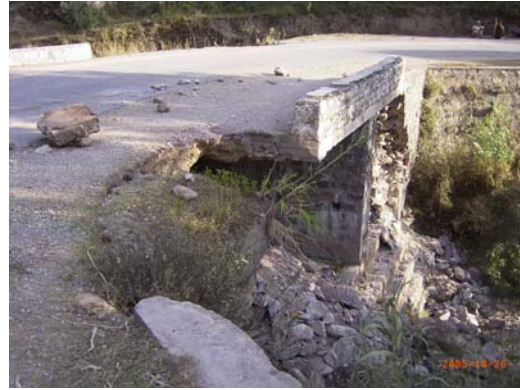
Fig. 21: Abutment failure of a bridge on a local road in south of Balakot

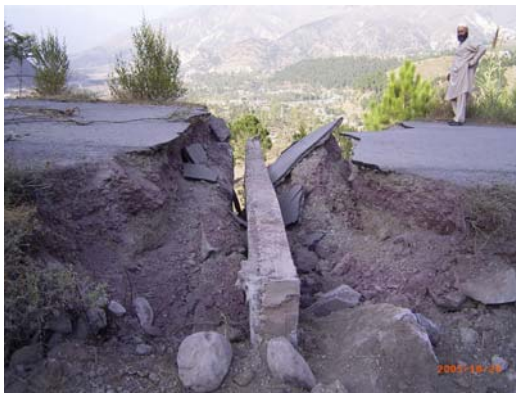
Fig. 22: Collapse of a culvert on a local road in south of Balakot

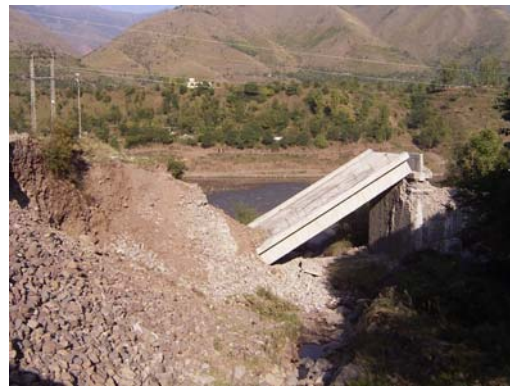
Fig. 23: Abutment failure of a bridge on Road No. 3, east of Muzaffarabad

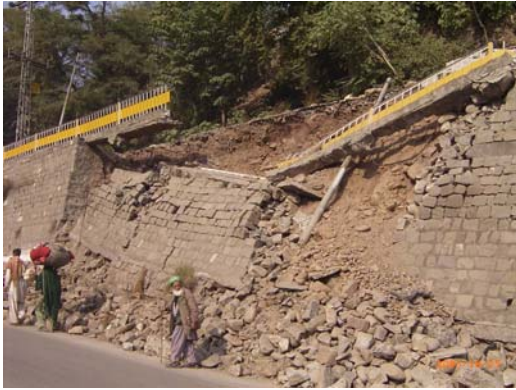
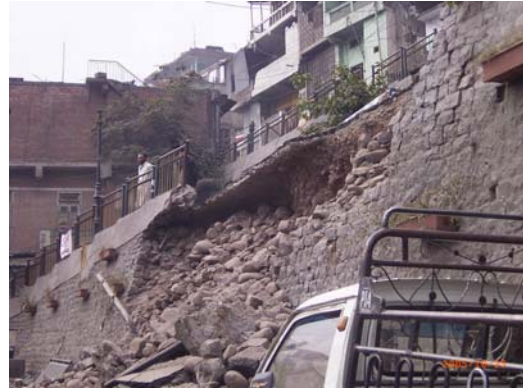
Fig. 24: Local road in Muzaffarabad

Figs. 24 and 25 show the collapse of retaining walls of local roads in the city of Muzaffarabad. The backfill material in these two cases is sub-rounded to rounded cobbles with very small fraction of fine material, rendering an inadequate backfill both in terms of material specifications and compaction.

Inadequate backfill both in terms of material specifications and compaction was observed in some cases of damaged retaining walls in Muzaffarabad region.

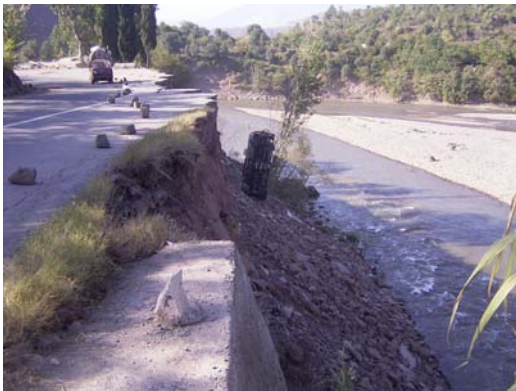
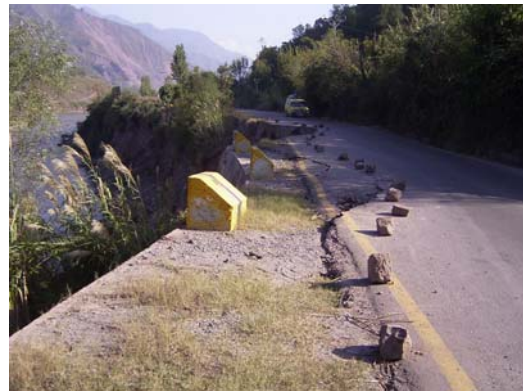
Fig. 26: Road No. 3, east of Muzaffarabad

Figs. 26 and 27 show the collapse of a retaining wall and backfill material on Road No. 3, east of Muzaffarabad. A truck met an accident during this collapse and can be seen standing vertical in the collapsed debris. Erosion from the river Jhelum water helped in the collapse.

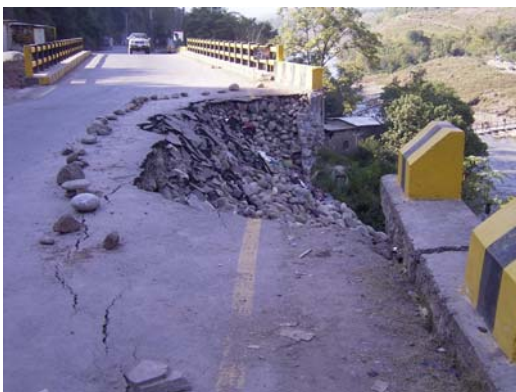
Fig. 28: Road No. 3, east of Muzaffarabad

Fig. 28 shows the collapse of the gravity retaining wall adjacent to abutment of bridge on Road No. 3, east of Muzaffarabad, near Garhi Dopatta. The retaining wall on the other side of the bridge also collapsed in a similar manner. As were the cases with the retaining walls shown in Figs. 24 and 25, the backfill material as seen in Fig. 28 is rounded to sub-rounded cobbles with very small fraction of fine material.

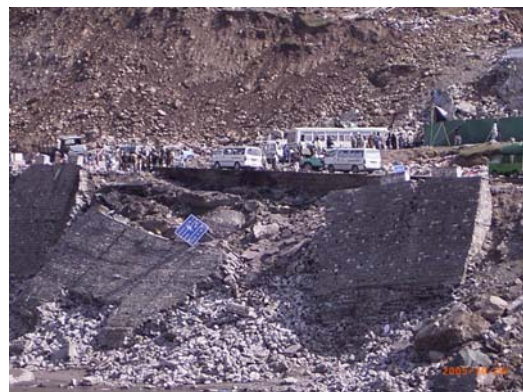
Fig. 29: Road No. 6, Balakot

In Balakot, a gravity retaining wall made of stone masonry was severely damaged (Fig. 29) due to massive ground deformations associated with landsliding.

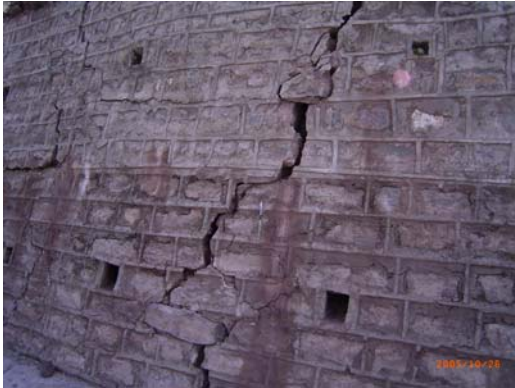
Fig. 30: Road No. 6, north of Balakot

Fig. 30 shows massive tensile cracks in a masonry breast wall on Road No.6, north of Balakot, whereas Fig. 31 shows the collapse of a road segment (Road No.5, south of Balakot) due to combined effect of the earthquake and erosion by the river Kunhar thereby emphasizing the use of properly designed retaining structure.

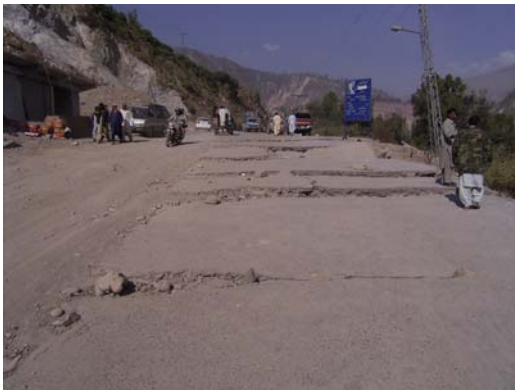
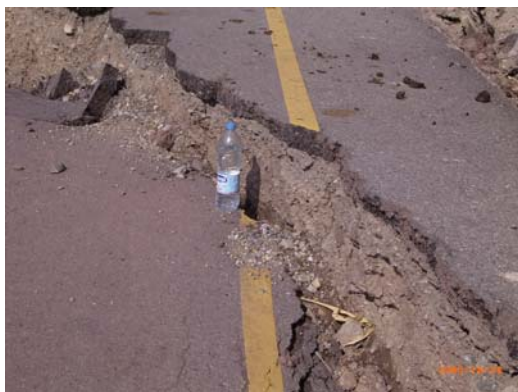
Fig. 32: Road No. 2, north of Muzaffarabad
(Site A in Fig. 36)

Numerous transverse and longitudinal road ruptures were observed in the affected area. Figs. 32 and 34 indicate that the measured horizontal and vertical movements of road ruptures were about 30 cm.

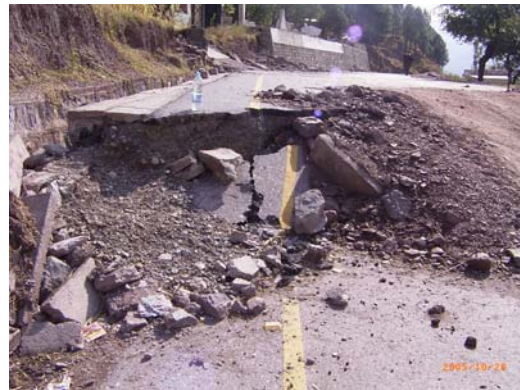
Fig. 33: Road No. 6, north of Balakot
(Site B in Fig. 36)

Fig. 33 shows huge dislocation of Road No. 6, north of Balakot. The vertical displacement is about 90 cm.
