DAMAGE TO ROADS CAUSED BY OCT. 8, 2005 NORTH PAKISTAN EARTHQUAKE

Obaid Hassan QURESHI ¹ and Junichi KOSEKI ²

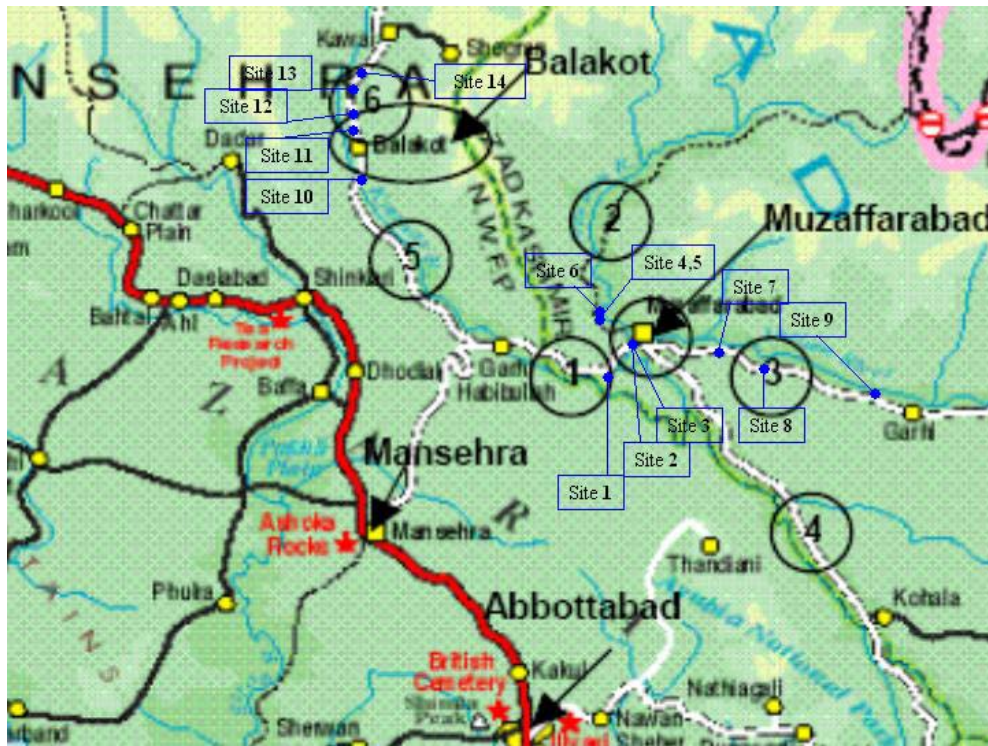
Fig. 2: Map showing the sites affected by slope instability on major roads

The road network throughout the earthquake zone suffered severe damage primarily due to landsliding. Slope failures were observed at various locations on roads in the affected areas. Some segments of the roads were open to the traffic during the time of visit whereas most of the length of some roads was not open as yet due to heavy landsliding e.g. Road No. 2, Road No. 6 and Road No. 7. Fig. 2 shows the sites on the main roads affected by the landslides. It is to be mentioned that these are only a few representative sites.

Landsliding and critical slope stability was a multi-scale problem that ranged from limited sloughing of surficial nature to a scale that encompassed entire mountain sides.

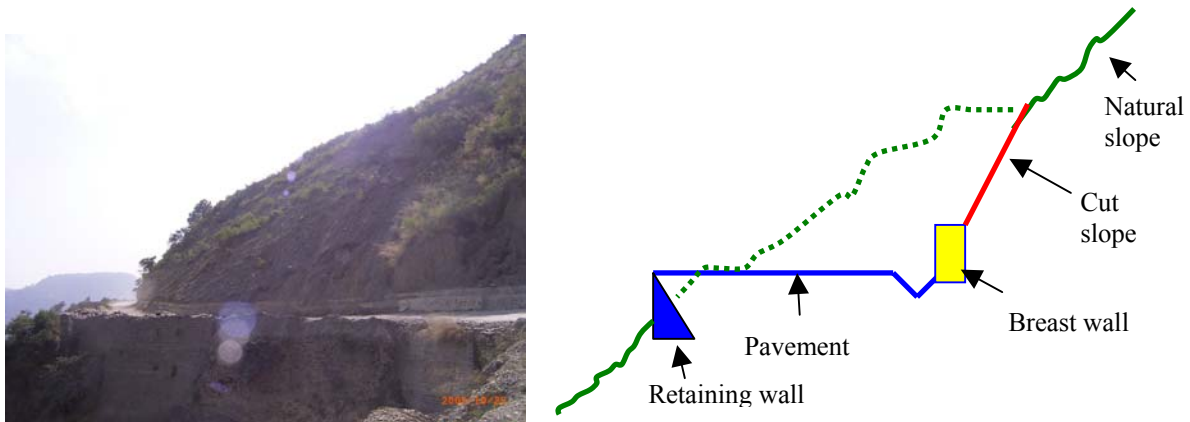
Fig. 3: Typical cross section of the roads in the affected area

Along the roads leading to Balakot and Muzaffarabad there was ample evidence of cleared landslides that blocked these roads. The roads in the affected area are constructed in cut. The typical section of the roads in the affected area is shown in Fig. 3. This geometry greatly helped in clearing most of the landslide sites for light traffic. The occurrence of these surficial landslides along the rather steep slopes is not unexpected. Most landslides appear to be in a meta-stable state and can be readily activated due to aftershocks or rain. Landslide hazard remains high throughout the affected areas.

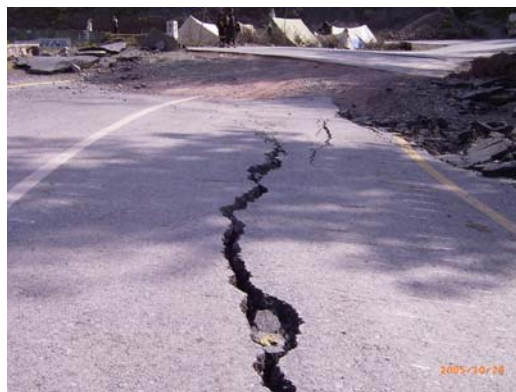
Fig. 35: Road No. 6, north of Balakot
(Site D in Fig. 36)

Numerous transverse and longitudinal road ruptures were observed in the affected area. Figs. 32 and 34 indicate that the measured horizontal and vertical movements of road ruptures were about 30 cm.

Tobita et al (2005) presented the deformation map of the area during this earthquake (Fig. 36). The sites shown in Figs. 32 through 35 are plotted on the deformation map here, which gives a hint that the ground ruptures at the above-mentioned sites can be the surface effects of underlying fault. But the detailed field investigation is necessary for reaching to a conclusion.
